REGULAR MONITORING REPORT (RMR)

Sub-Sector: Water Supply & Drainage

1. Scheme / Unit Information								
a.	ADP / UID No.	2455 (2025-26)/ PHEWS-PP-22-1082						
b.	Name of the Project / QRC	Water Supply Scheme (Ultra Filtration Plant) at Ratodero (Revised)						
c.	Visit Location of the Project	UC/Town	Ratodero Town		District	Larkana		
d.	GPS Location Coordinates	Lat (N):	27.76388148		Long (E):	68.30872033		
e.	Administrative Department	Public Health Engineering & Rural Development Department, Govt of Sindh						
f.	Executing Agency	Executive Engineer, PHED Division-I, Larkana.						
g.	Consultant / Design Engineer	N/A						
h.	Contractor (s)	M/s Mohammad Iqbal Shaikh & Co.						
i.	Date of A.A. Issued	09-06-2022	Completion Month/Year as per PC-I		June-2027			
j.	Revision of PC-I Status	Approved, 1 st revise.	Date of Revision (if any)		03-03-2025			
k.	Project Objectives (as per PC-I)	Supply drinking water to the inhabitants of town.

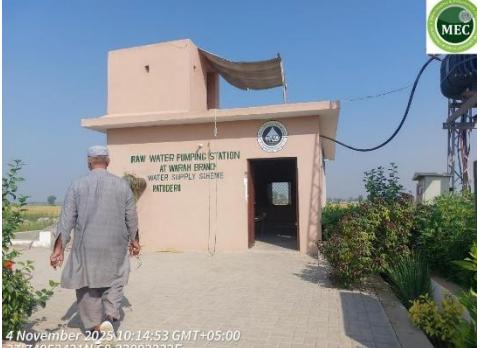
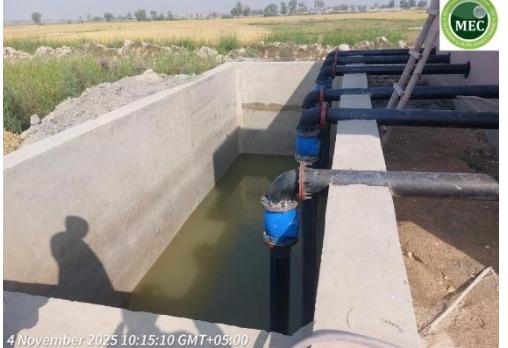
S#	Specific Observations (Note: No specific observation was recorded, however, photographs of various components executed at the site are attached below for reference.)	Pictures	
1.	Pump room and collecting sump constructed at Raw water site

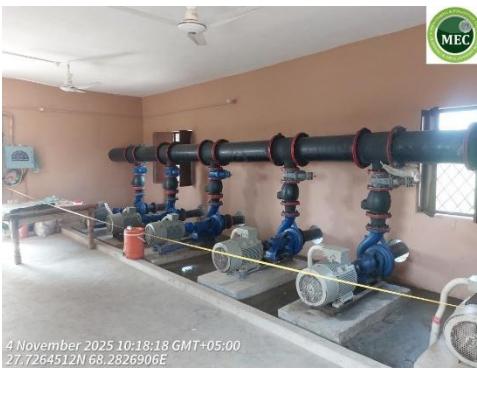
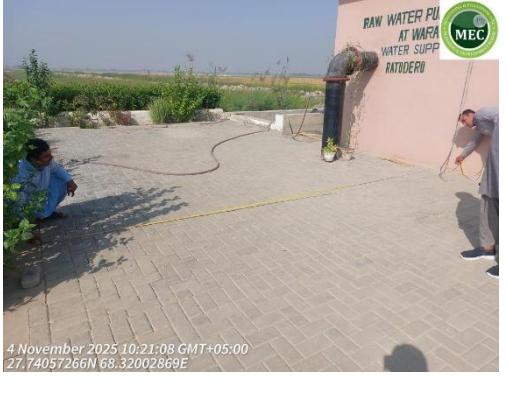
<small>4 November 2025 10:15:10 GMT+05:00 27.74059462N 68.31992959E</small>
2.	Machinery installed and pavers fixed at Raw water site

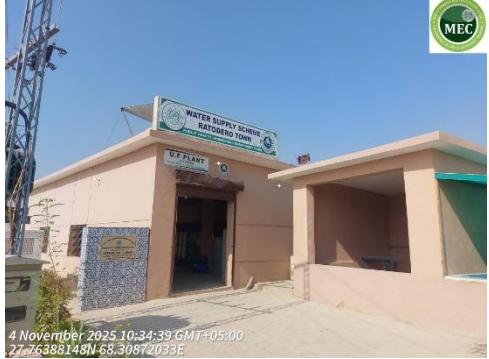
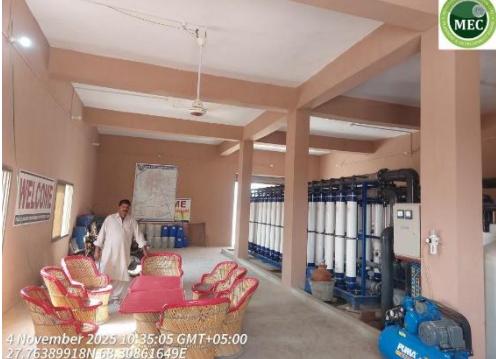
3.	<p>Ultrafiltration plant room constructed at Water works site</p>

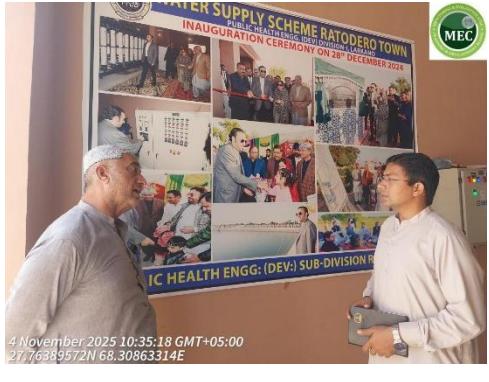
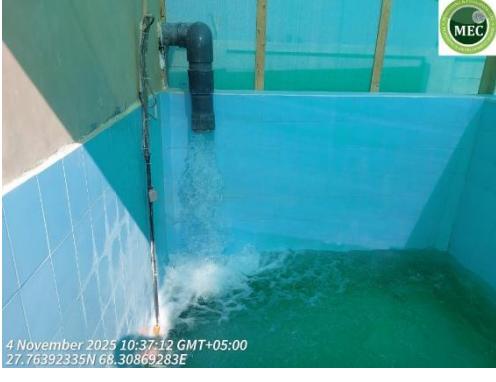
<p>4 November 2025 10:35:05 GMT+05:00 27.76389918N 68.30861649E</p>
4.	<p>AEN briefing about the scheme and aw water is treated through the ultrafiltration plant and subsequently collected in the clear water sump for further distribution to the inhabitants.</p>

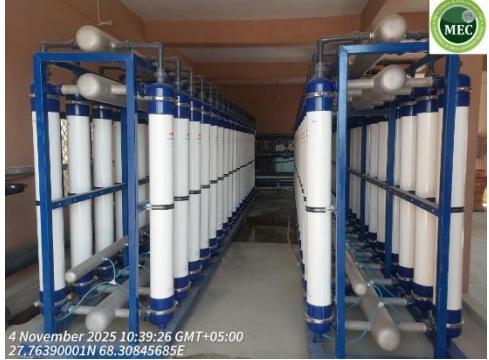
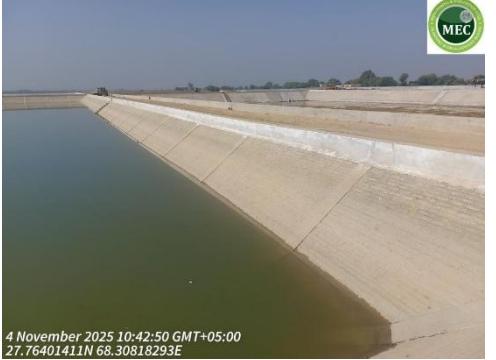
<p>4 November 2025 10:37:12 GMT+05:00 27.76392335N 68.30869283E</p>
5.	<p>Membranes installed in Ultrafiltration plant and brick lining done on walls of storage tank filled with raw water.</p>

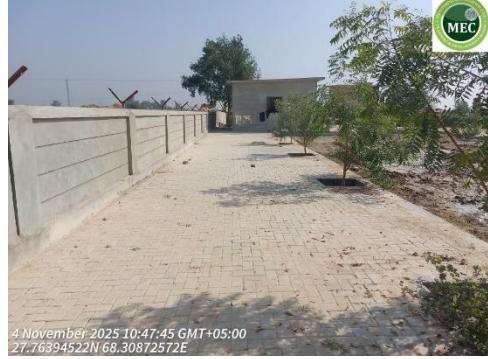
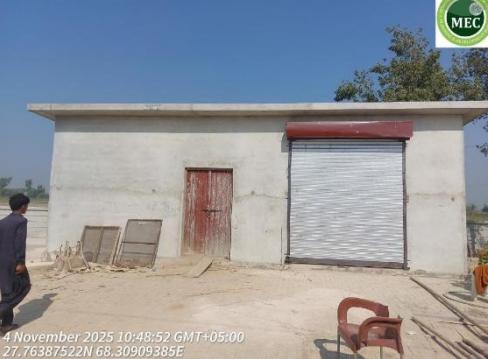
<p>Compound wall constructed, pavers laid on path ways and plantation done at water works site. Generator and store room were also constructed.</p>

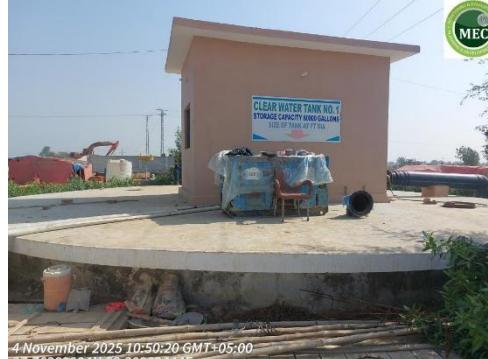
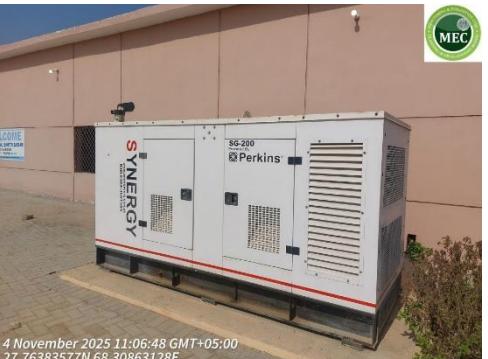
<p>Roof slab of existing clear water tank was replaced and pump room constructed over that. Perkins made Generator installed at water works site.</p>

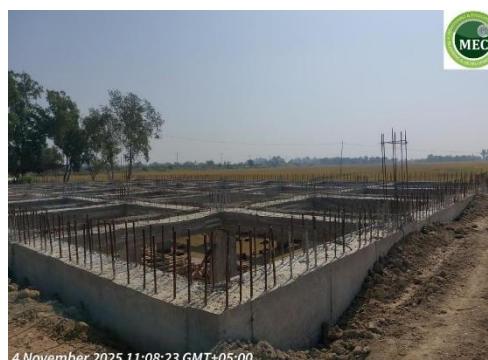
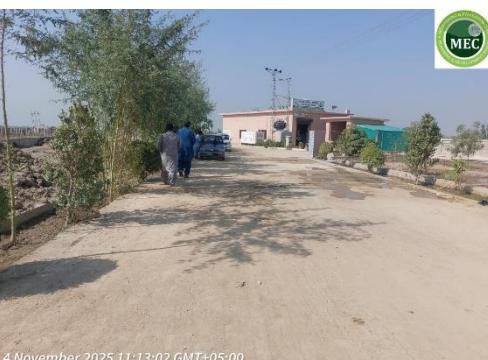
<p>Clear water tank constructed up to roof level and pavers laid on the main pathway on the water works site with plantation on both sides.</p>

i. Proper curing of the newly constructed RCC clear water tank should be ensured to achieve the required structural strength and durability.	
		ii. The remaining three storage tanks at the water works site, which are near completion, should be completed at the earliest to ensure full operational capacity.	
		iii. The quality of brick lining, RCC roofing, and paver block work should be verified through regular inspections to maintain construction standards and longevity.	
		iv. A regular maintenance schedule should be implemented for all electrical and mechanical equipment including motors, generators, and filtration units.

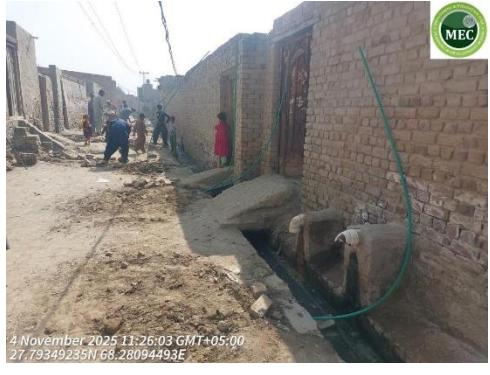
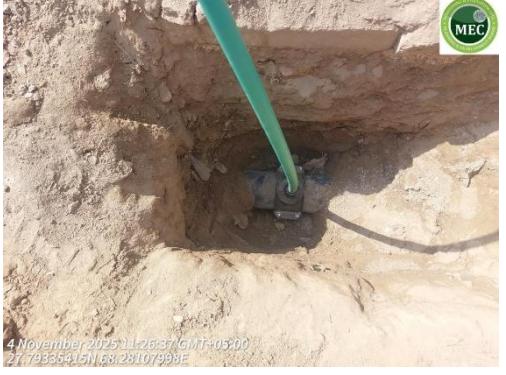
<p>House connections done and distribution pipe verified through a pit.</p>

v. The distribution network should be rechecked for leakages, pressure levels, and uniform water supply to all connected households.	
		vi. Electric connection of the express feeder should be energized at the earliest, as payment has already been made and material has been installed. Only the grid connection is pending, which will facilitate uninterrupted power supply to the water supply system and ensure continuous provision of drinking water to the inhabitants.	
		vii. Plantation and landscaping around both raw water and water works sites should be maintained and expanded for environmental and aesthetic improvement.
